关于晶片电阻两端电极外观说明

About the Appearance of the Electrodes at both Terminals of the Chip Resistor

§0.摘要 Description

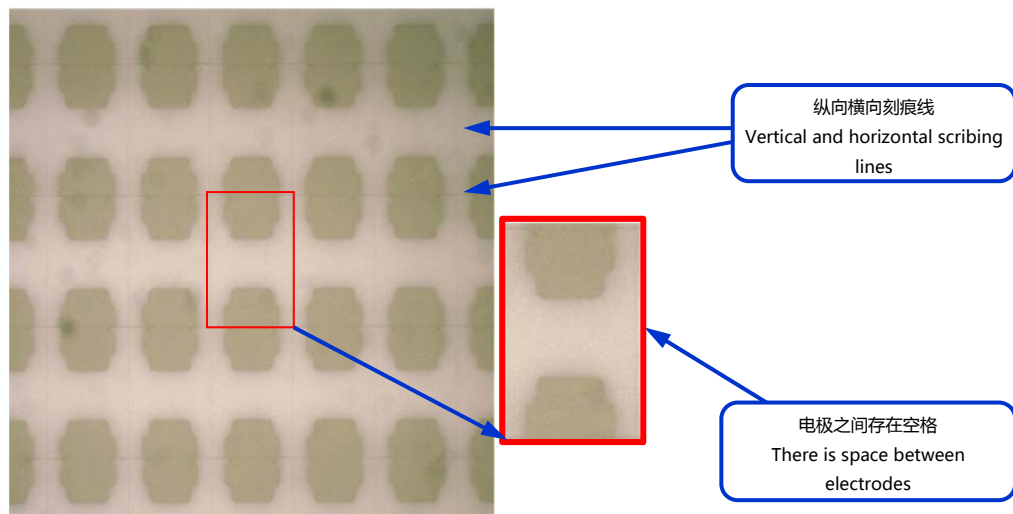
图 1 正电极印刷图片

1.1 电阻正面电极印刷的照片(如下图 1)可以看出，正面电极为粒状印刷。

As can be seen from the printing image of top electrodes (as shown in picture 1), top electrodes are printed in the way of granular printing.

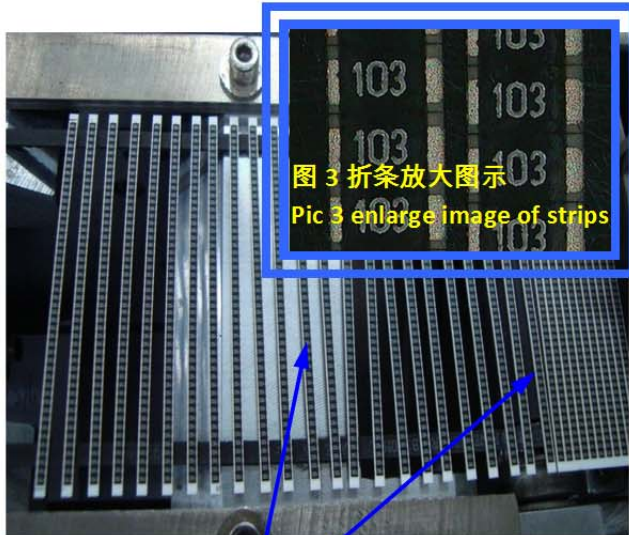
图 2 折条图示
Pic 2 Breaking into strips

基板通过设备折成条状
Substrates are broken into strips by the machine

1.2 电阻在折成条状后会放入溅射治具中，条状后外观可以明显看出正面电极粒状，粒与粒之间的电极是有空隙的(如图 3)，折条后产品会放入溅射治具，半成品堆叠在一起形成一定的间隙(如图 4)

After the substrates are broken into strips, they will be put into the sputtering cartridges. By observing the strips in the cartridges, it can be seen that the top electrodes are granular shape, and there are gaps between the chips (picture 3). When substrates are broken into strips and put into the sputtering cartridge, there are gaps between stacked semi-finished products (picture 4).

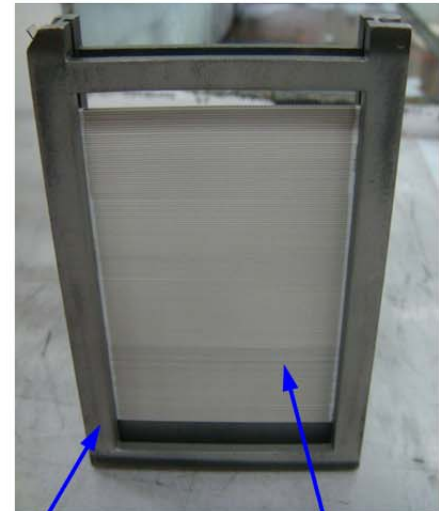
图 4 堆叠图示
Pic 4 Stacking

仓夹
Strip cartridge

条状半成品堆叠，在仓夹中溅射侧电极
Strips are stacked in cartridge for sputtering

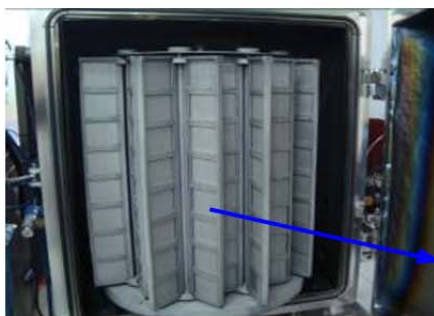
图 5 真空溅射炉图示
Pic.5 Vacuum sputtering chamber

1.3 真空溅射炉如下 Vacuum sputtering chamber :

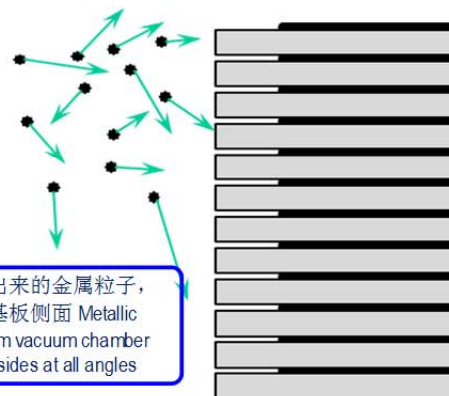
图 6 堆叠示意图
Pic 6 Stacking

真空仓中被激发出来的金属粒子，
不同角度溅射在基板侧面 Metallic
particles sprayed from vacuum chamber
sputter on substrate sides at all angles

1.6.1 在真空溅射炉中进行侧面电极底层材料溅射, 因为印有导电层、保护层及字码的半成品存在一定的膜厚, 半成品堆叠在一起形成一定的间隙, 而不同产品之间膜厚会存在不一样, 因此, 在溅射最终形成的侧电极底层材料深度和多少都存在差异; 有的溅射深度深, 形成的材料厚度略厚, 有的溅射深度浅, 甚至没有。

As there is a certain film thickness of semi-finished products printed with conductive layer, protective layer and marking; thus, there will be certain gaps between semi-finished products when stacked up, and the film thickness will be different between different products. Therefore,

there will be difference in the depth and the amount of sputtered layer on the top electrodes: some sputtering depth is deep, the thickness of the material is slightly thick, some sputtering depth is shallow, or even no sputtered layer on the top electrodes.

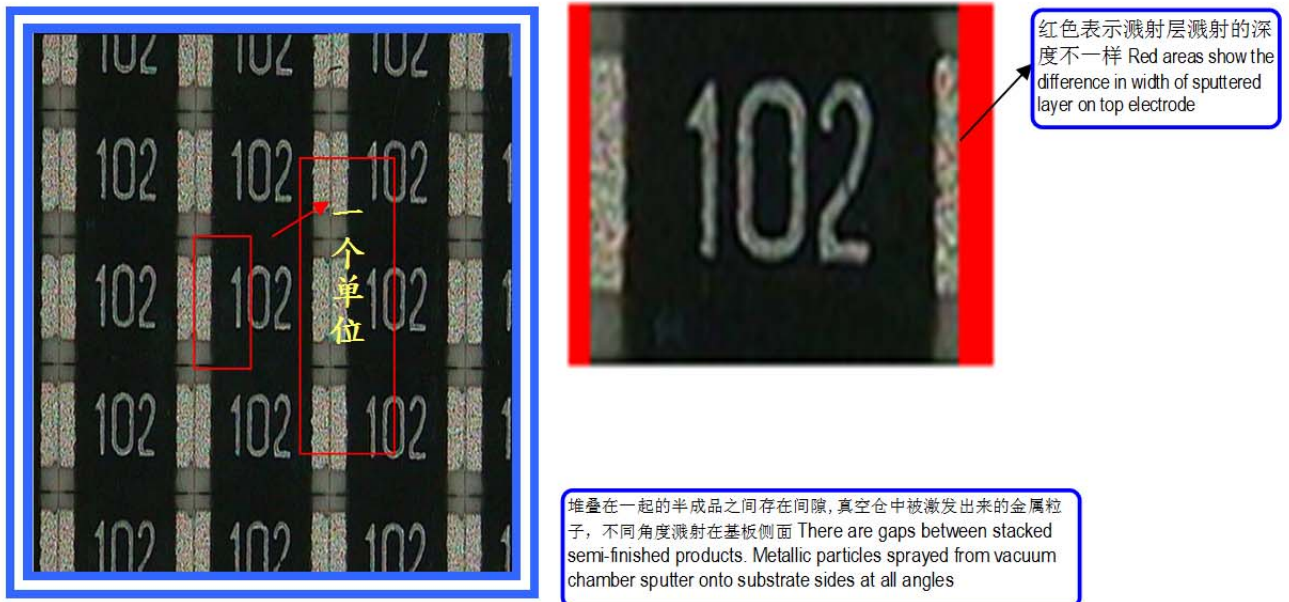
图 8 真空溅射前图示
Pic 8 before vacuum sputtering

1.4 溅射前、后示意图如下 Before and after sputtering :

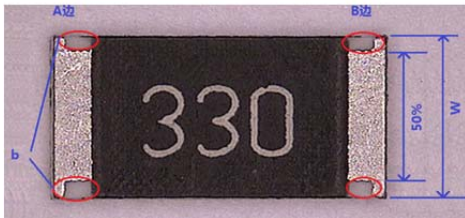
图 11 电镀后电极图示

电阻正面电极缺失面不能大于基板总宽 W 的 50% (指每个单边 A 或 B)，如下图 11 所示。

The blank area of the top electrodes of the resistor shall not be greater than 50% of the total width of the substrate W (referring to terminal A or terminal B), please refer to pic 11 as follows.
