## About the Appearance of the Electrodes at both Terminals of the Chip Resistor

### §0. Description

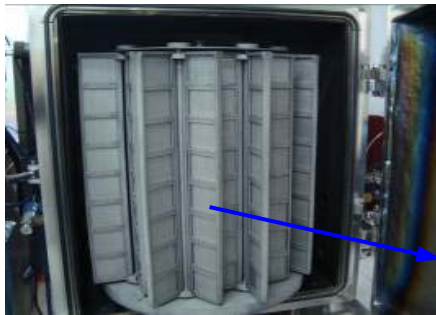
Pic.5 Vacuum sputtering chamber

### 1.3 Vacuum sputtering chamber :

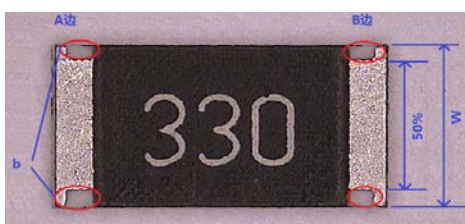
Pic 11 image of the electrodes after electroplating

The blank area of the top electrodes of the resistor shall not be greater than 50% of the total width of the substrate W (referring to terminal A or terminal B), please refer to pic 11 as follows.

- 1.6.2 After sputtering the terminal electrodes; electroplating process will be carried out, nickel layer and tin layer are plated on the materials and finally form the end electrode appearance the same as that of the product shown in the image, which is the normal phenomenon and won't affect solderability and resistor performance. This phenomenon also exists in products of competitors and won't affect customer application.
