## Anti-sulfurized resistors are recommended for special circuits

### §0 . Abstract

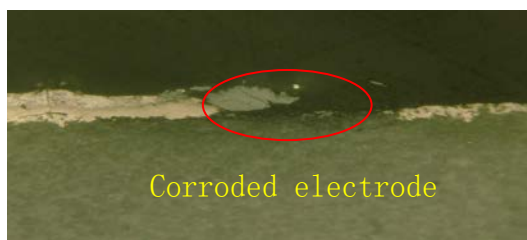
When there are corrosive substances such as S, Cl or Br in external atmosphere, they may enter the gap and react with the silver layer, resulting in partial non-conductivity or poor conductivity of the silver layer. In serious cases, the silver layer will be disconnected, resulting in OPEN resistance value. Figure 1 shows the phenomenon of an electrode being sulfurized (corroded), the silver layer below the plating layer at the junction of the top electrode being corroded, and Figure 2 shows the normal condition of an electrode.

Figure 1 Left top terminal is corroded

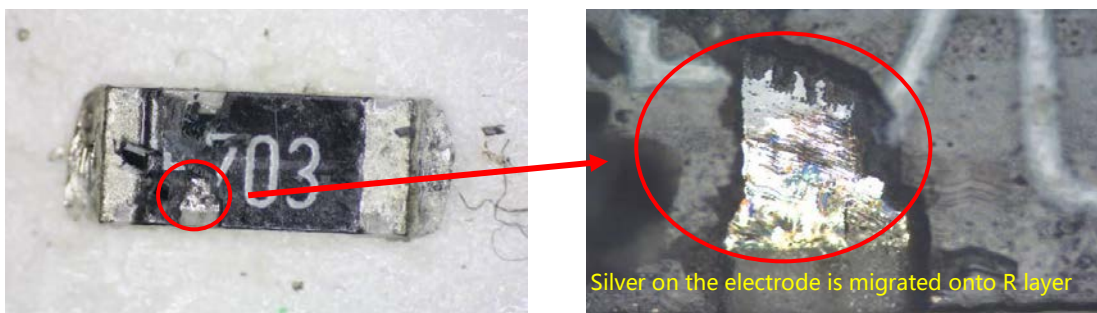
After Cl and Br elements have entered the gap, and under DC voltage, silver on the electrode is migrated, resulting in a disconnection between the electrode and the resistance layer and consequently an OPEN resistance value. The migration appearance is shown in Figure 8.

Figure 8 migration appearance

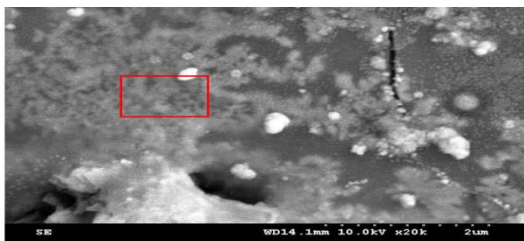
Figure 11 Magnified detection area 1 of Figure 10
