## Test Report

No. SHAEC1810437602

The following sample(s) was/were submitted and identified on behalf of the clients as : Metal Oxide Film Fixed Resistors

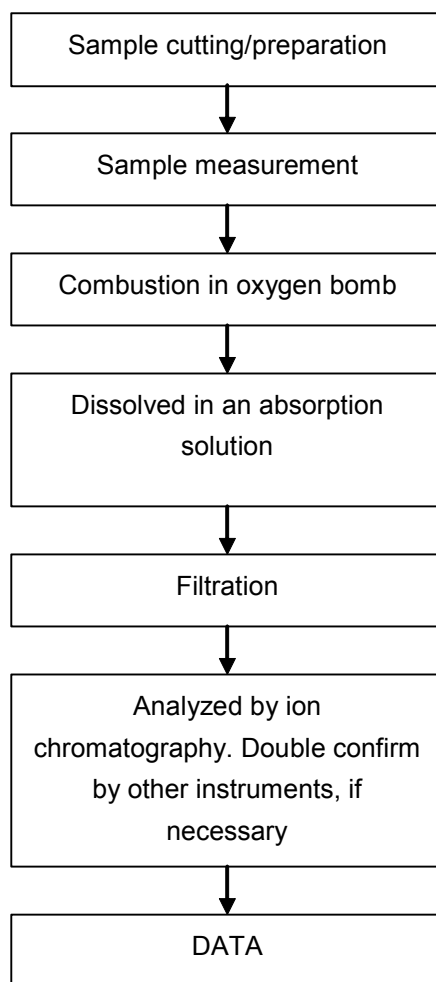
### Halogen Testing (oxygen bomb) Flow Chart

Test Method : With reference to EN 14582: 2016 , analysis was performed by IC.

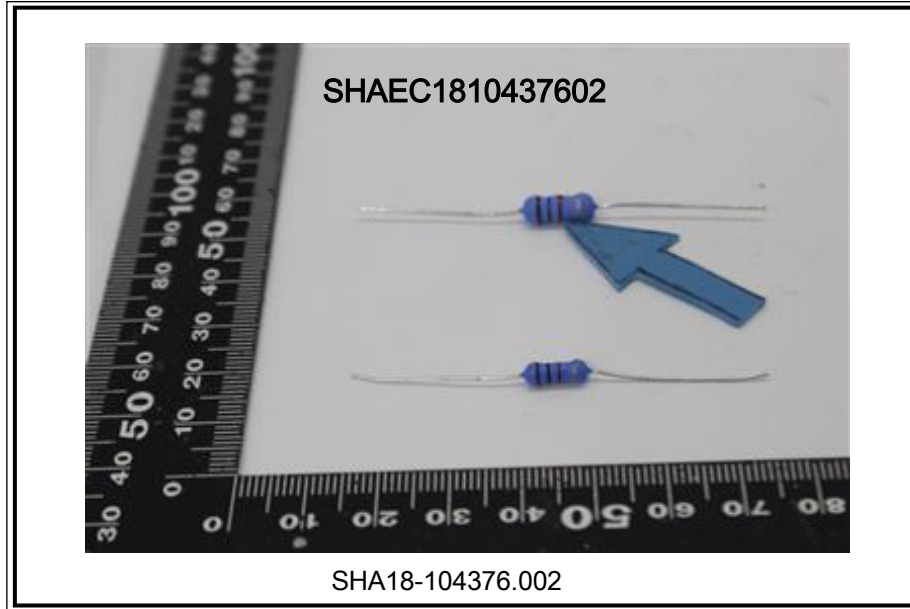
Sample photo:

Specimen No.	SGS Sample ID	Description
SN1	SHA18-104376.002	Colorful body part
